## Shoreline Assessment Sprague Lake

Survey Completed October 2022

Report Created June 2023

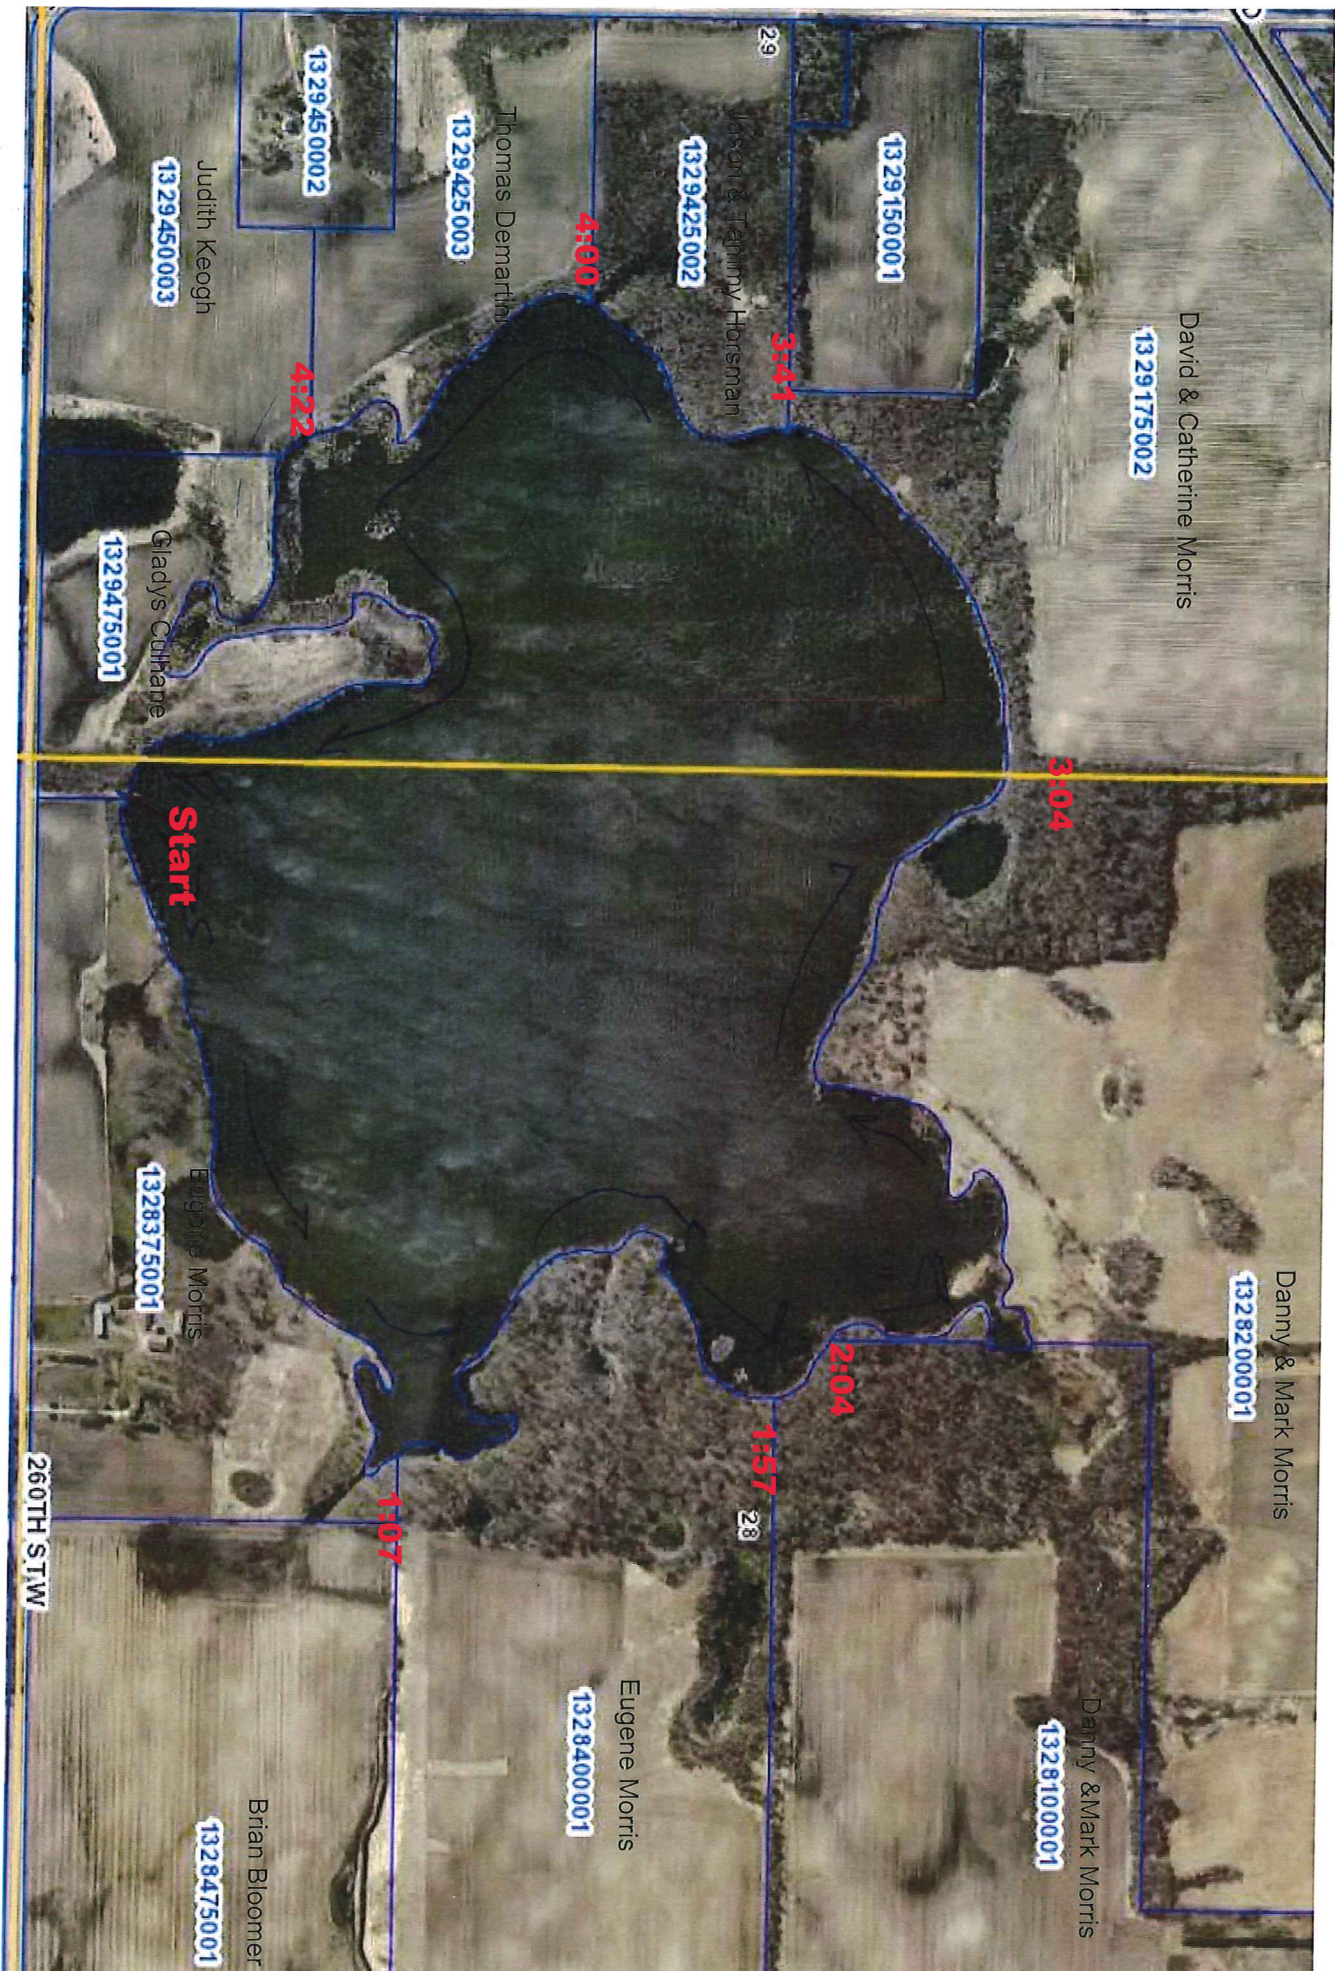
## **Appendix A – Map of Flight Path**

Below is the table for Score Your Shore for the 9 parcels on Sprague Lake, listed counterclockwise starting at the MNDNR access. The flight path and time stamp of the video is also noted on the map in Appendix A. The drone video is posted on the CRWJPO YouTube page:
