Toners Lake Shoreline Survey

Waseca County, Cannon River Watershed

October 2023

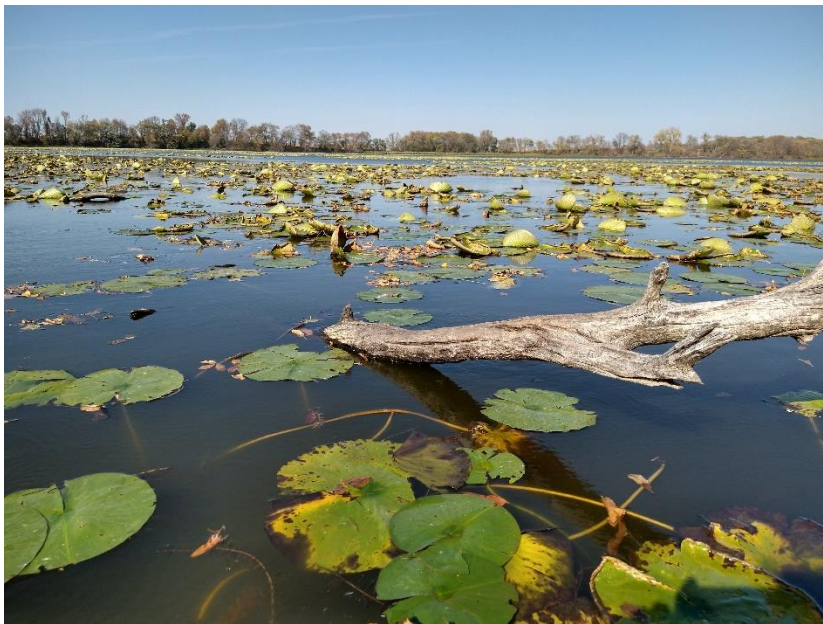
Lily pads and log on west end of lake

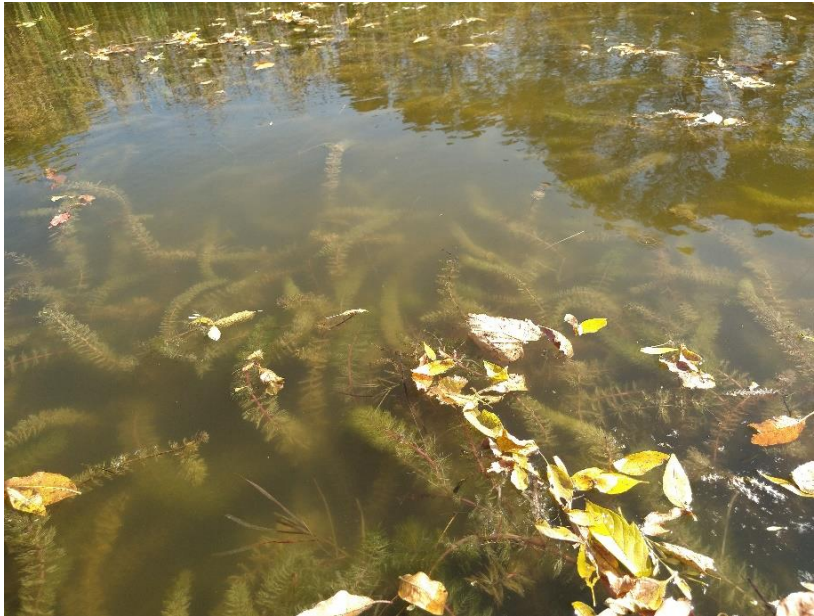
southern shorelines but appeared to be the product of steep topography and an exposed lakebed from the low lake water level. Significant algal blooms were observed across much of the lake, with water clarity (secchi value) less than 6 inches. Both survey days were windy which may have contributed to poor water clarity. Despite such low water clarity, submerged aquatic plant growth occurred in areas where lake depths were low, with dense aquatic macrophyte beds occurring in areas. Wildlife observed included swans, ducks, Canada geese, clams, muskrat, and minnow fry.

Representative photo of water clarity and submergent vegetation

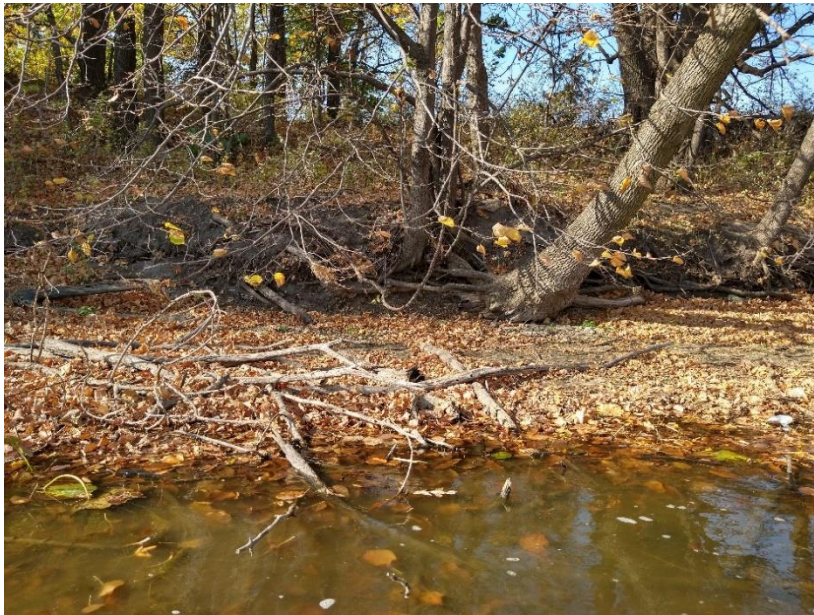
The following is a summary of the shoreline assessment and includes individual lakeshore scores derived from the Score Your Shore evaluation. Four parcels were assessed around Toners Lake, with all of the parcels split into multiple sections due to shoreline characteristics. The result was an assessment of 14 individual shorelines on four parcels (Appendix B & C). Shoreline scores ranged from 105-200 points, with an average score of 146 points. Most shorelines contained excellent shoreline tree and shrub cover, shoreline ground cover, aquatic macrophyte growth and overhanging woody cover. Active shoreline erosion was minimal and limited to likely wave erosion and some sheet and rill erosion on steep shoreline slopes. Small cutbanks less than 1 foot in height were observed along several of the northern and

Photo showing low water levels and shoreline erosion

Altered shoreline on Toners lake is limited to minimal disturbance for one dock and likely some historic alteration for the county road on the south side and the private driveway on the east side. Areas with steep shoreline should be monitored for erosion concerns. Aquatic vegetation along the shoreline and terrestrial vegetation on the bank should be protected from human disturbance. There was some minimal populations of buckthorn along the shore and within the county park that should be removed by cutting

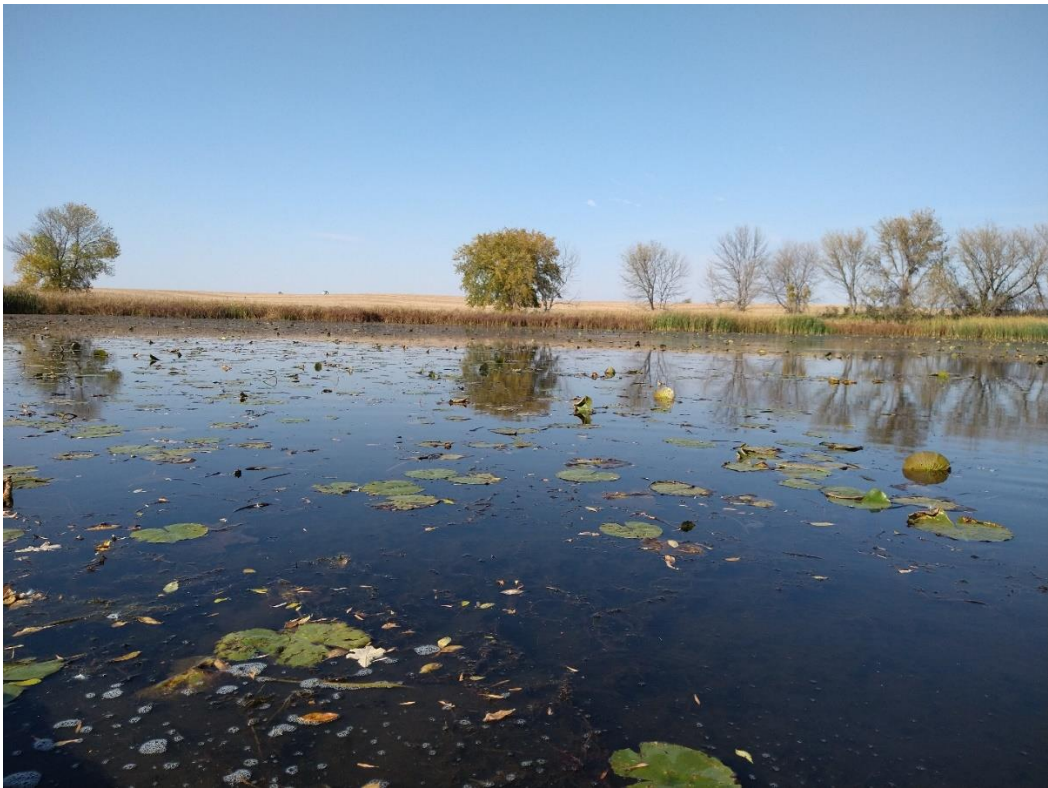
Section 6

50160400	6	660	125	Cattail, dark green bulrush, coontail, and lily pads present.	0	5	0	15	15	40	35	5	10	0	125
50160400	7	800	105	lily pads 150' from shore.	0	0	0	20	15	10	35	5	10	10	105
50090800	8	320	105	lily pads 150' from shore.	0	0	0	20	15	10	35	5	10	10	105
50090800	9	460	183	cattails, coontail, and end of lily pads.	18	15	15	20	15	40	35	5	10	10	183
50090800	10	1000	105	lack of emergent vegetation due to overhanging trees.	0	0	0	20	15	10	35	5	10	10	105
50090200	11	500	200	cattails - adjacent to county park	25	20	20	20	15	40	35	5	10	10	200
50090200	12	1500	200	cattails, bulrush, coontails, and lily pads present. Clear water 6" deep in bay. Water level low enough that bay is connected to main lake by 1 inch of water.	25	20	20	20	15	40	35	5	10	10	200
50160610	13	1800	144	lack of emergent vegetation due to overhanging trees. Cattails, bulrush, softstem bulrush, and coontail present.	9	5	5	20	15	30	35	5	10	10	144
