Shoreline Assessment Roemhildts Lake

Survey Completed October 2022

Report Created June 2023

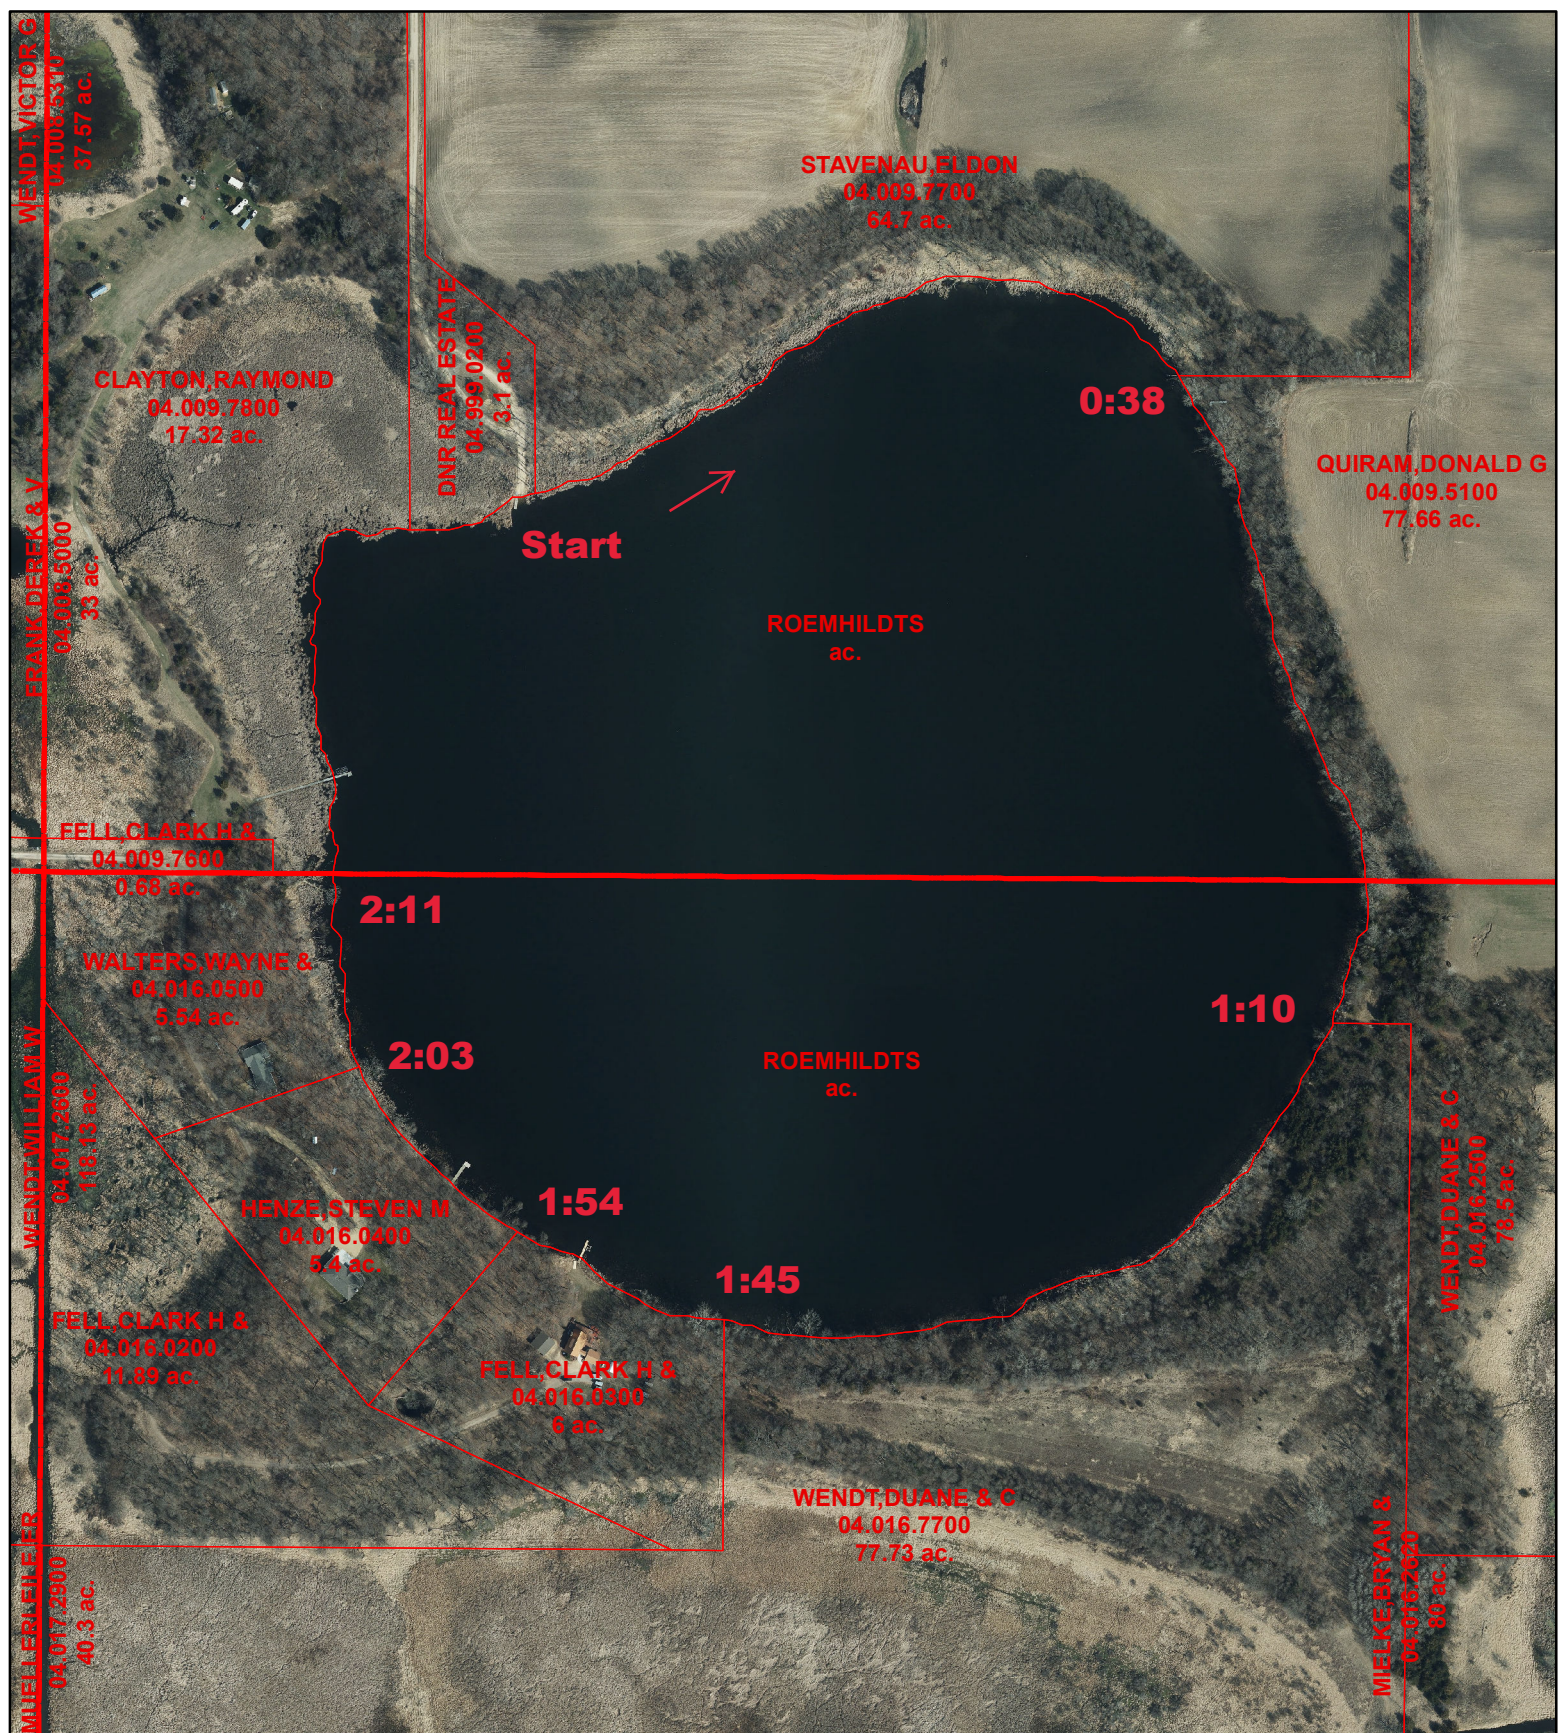
Appendix A – Map of Flight Path

Below is the table for Score Your Shore for the 8 parcels on Roemhildts Lake, listed clockwise starting at the DNR access. The flight path and time stamp of the video is also noted on the map in Appendix A. The drone video is posted on the CRWJPO YouTube page: <https://www.youtube.com/@crwjpo>
