Shoreline Assessment Fish Lake

Survey Completed October 2022 Report Created June 2023

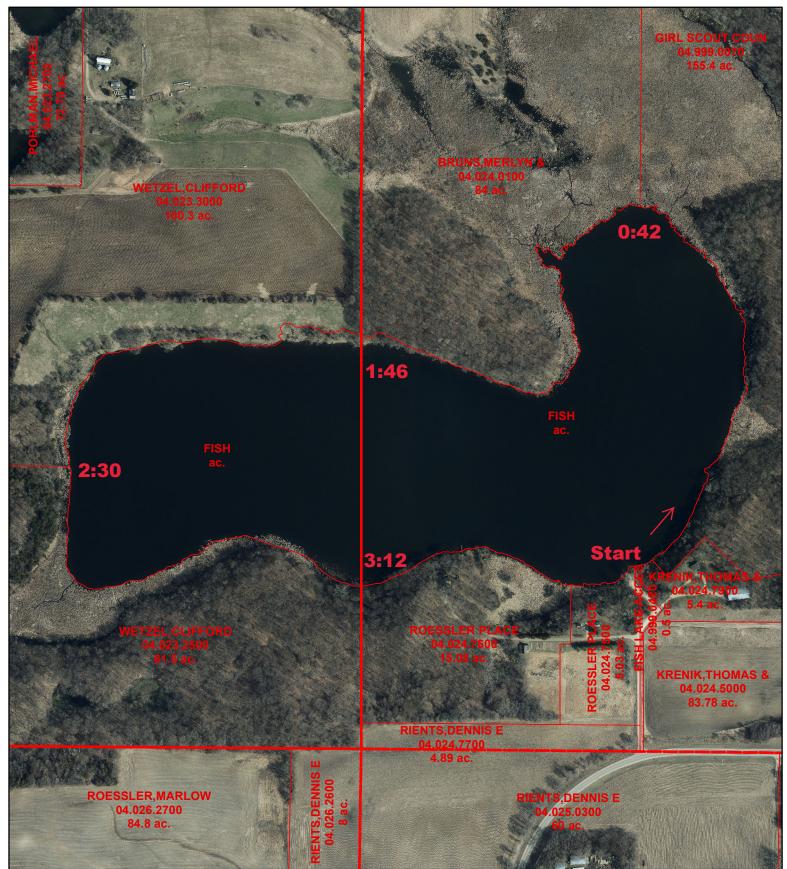
Appendix A – Map of Flight Path

Below is the table for Score Your Shore for the 7 parcels on Fish Lake, listed counterclockwise starting at the DNR access. The flight path and time stamp of the video is also noted on the map in Appendix A. The drone video is posted on the CRWJPO YouTube page: <u>https://www.youtube.com/@crwjpo</u>
